Summary of PHENIX Drift Chamber West repair in July-August 2010

Benji Levis, Vlad Pantuev, Yuri Riabov, Eugene Roschin

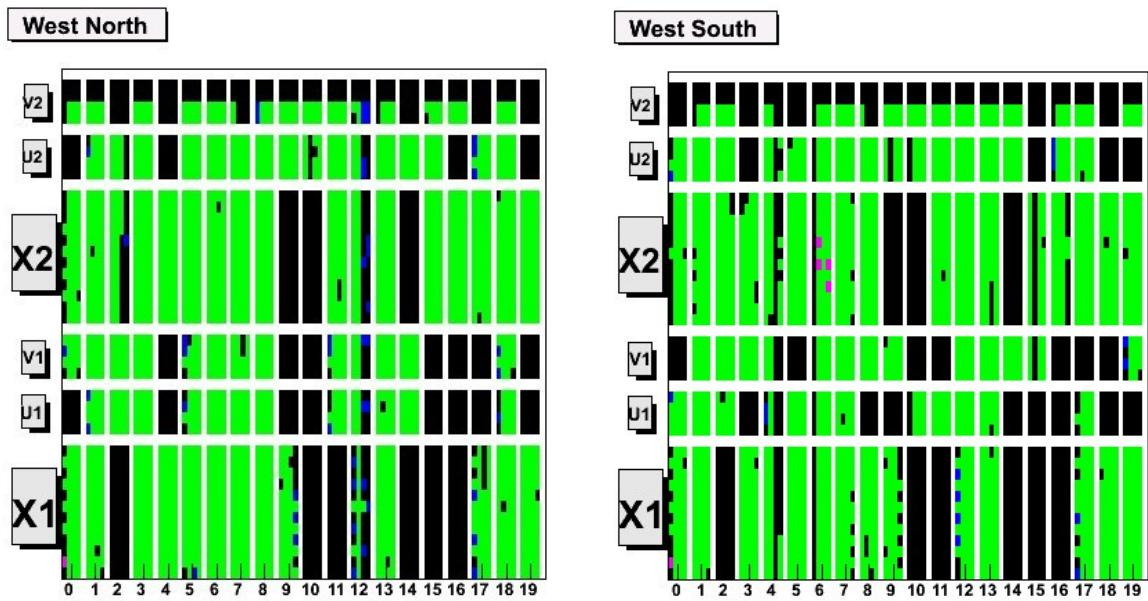
Fig. 1 shows an example of the online monitoring output near the end of Run 10. There were six non-working modules in X1 section: sectors 2, 10, 11, 14, 15, 16; three bad modules existed in X2 sectors: 9, 10, 12. These issues were mostly the result of HV problems and broken wires inside the chamber. Shorts induced by broken wires are highlighted in red in Fig. 2. HV problems were accumulated over the 10 year period of operation, such as the cathode problem in sector X1_5 and weakness in other HV potentials in sectors X2_6, X2_8, X2_9, X2_12, X2_14. Fig. 3 displays the cards from the DC electronics that have a problem. In total we had ~38% loss for tracks with quality 63 (track reconstructed in X1 and X2 planes).

Fig.1. Online monitoring page at the end of Run 10.

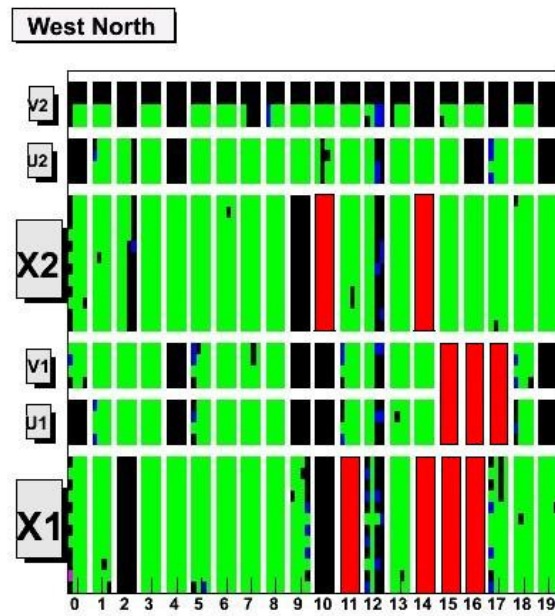
Fig.2. Shorts induced by broken wires indicated in red.

1. Removal of broken wires. The following three broken wires were removed (nets are numbered from the bottom in each sector):

1. *X2_14_2 - Termination wire (at large radius).*
2. *X1_11_3 Gate wire.*
3. *U1_16_2 Termination wire.*

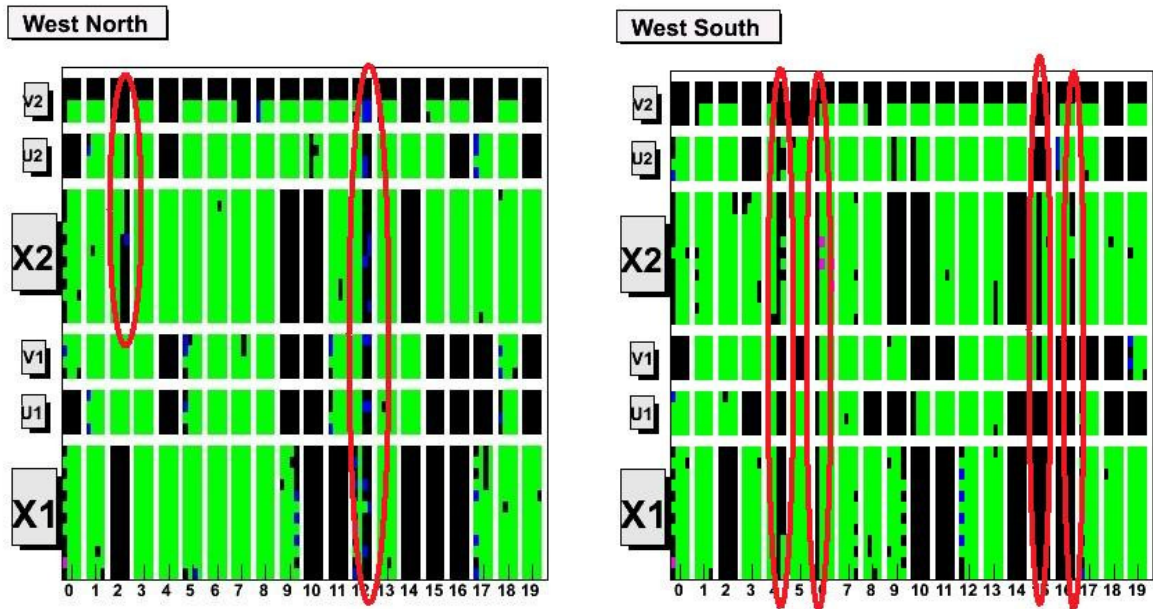
Fig.3 Problems with electronics

3. Board removal and repair: The following boards were removed and sent to Stony Brook for testing and repair (numbering from the bottom):

1. N2 → board 3, 4
2. S6 → board 1
3. S4 → board 3, 4
4. N12 → board 3, 4

5. S16 → board 4
6. S15 → board 2

In cases 1 and 4 no problems were identified during the tests at Stony Brook, thus we put these boards back to the chamber without any fix (unfortunately problems were still there as we found during the final tests on the chamber, see below). For the remaining cases, work was performed on the boards at Stony Brook.

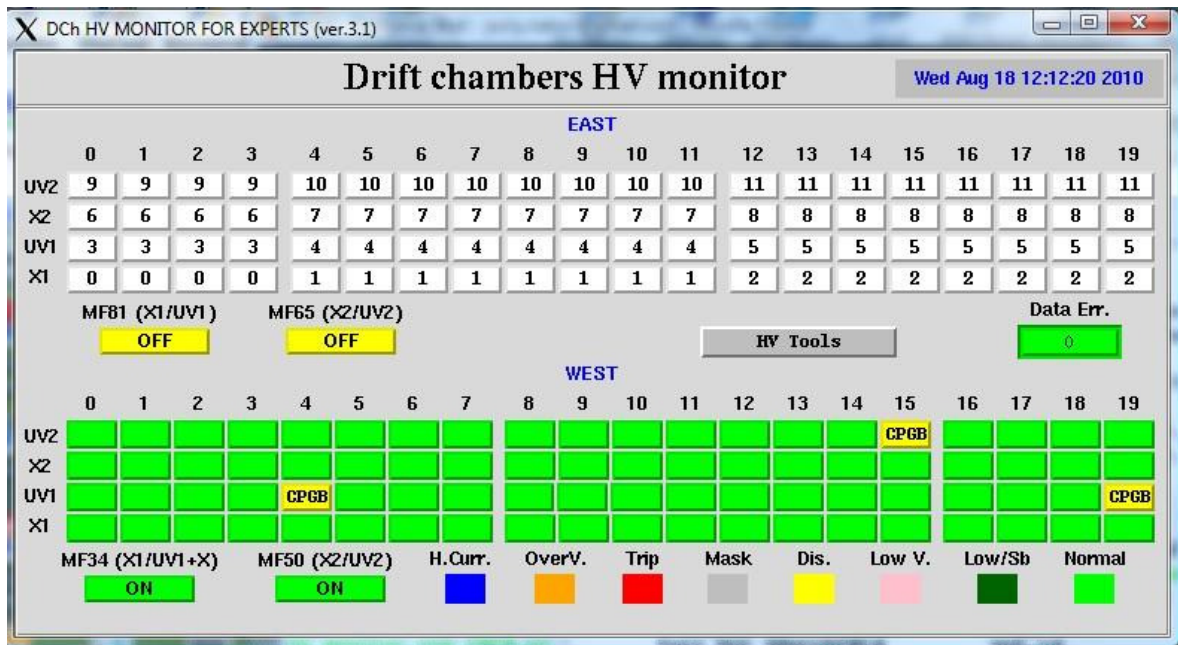
Non-flammable gas mixture Ar/CO₂ 85/15. All sectors set at the same HV regime identical to nominal working conditions. During an eight-hour test there were 3 random trips (not

correlated with repaired sectors), which could be attributed to the fact that a less stable gas mixture was utilized, specifically with 15% CO₂ instead of 50% C₂H₆ (Ethane). In Fig.5 we show disconnected nets. Total loss from HV is 7/80=8.75% of the West acceptance (at the end of Run 10 was 38%).

Fig. 4. Online HV monitor after repair

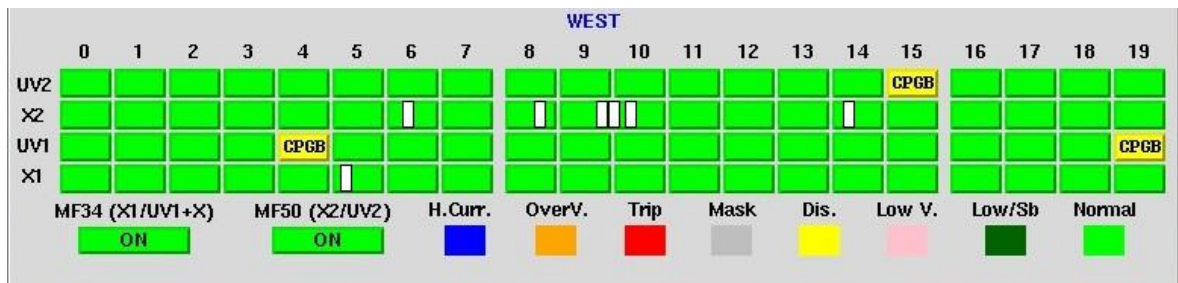
Fig.5. Location of disconnected nets are overlaid onto Fig. 4.

2. Disconnection of weak nets from HV power supply:

1. *5X1_2_C (second Cathode net from the bottom in sector 5X1)*
2. *6X2_2_PGB (Potential, Gate and Back wires were disconnected)*
3. *8X2_3_PGB(the same). Here we also fixed HV contact - cold soldering*
4. *9X2_3_C*
5. *9X2_4_C (small cathode near Strut)*
6. *10X2_2_PGB*
7. *14X2_2_PGB*

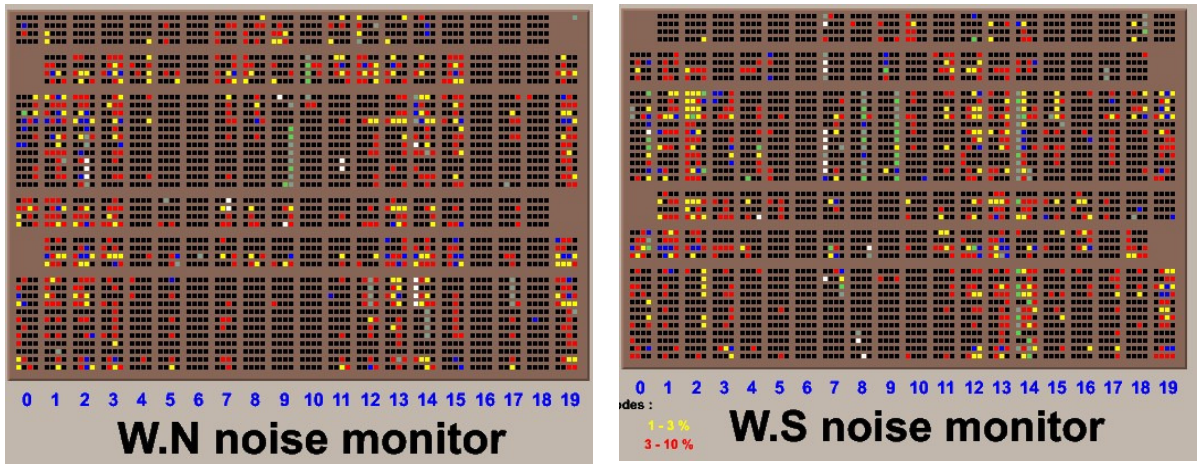
A very low registration threshold of 3 fC (nominal is 5-6 fC) was set for all electronics channels, as seen in Fig. 6. Black color means that the channel is overflowed by noise. Other colors reflect spread of the RF noise. Thus, most of channels are alive.

Fig. 6. Online monitoring at low 3 fC threshold

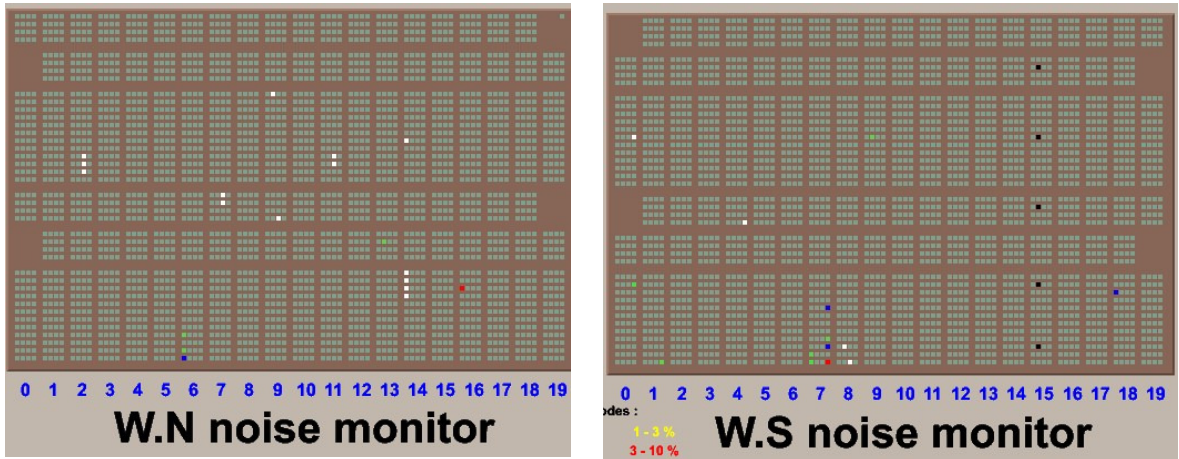
Fig. 7 is the result of setting the thresholds to values used during physics running. The remaining noisy channels (not gray) will be masked. There is also a strange pattern with increment +8 in south sector 15, board #2.

Fig. 7. Online monitoring with nominal thresholds.

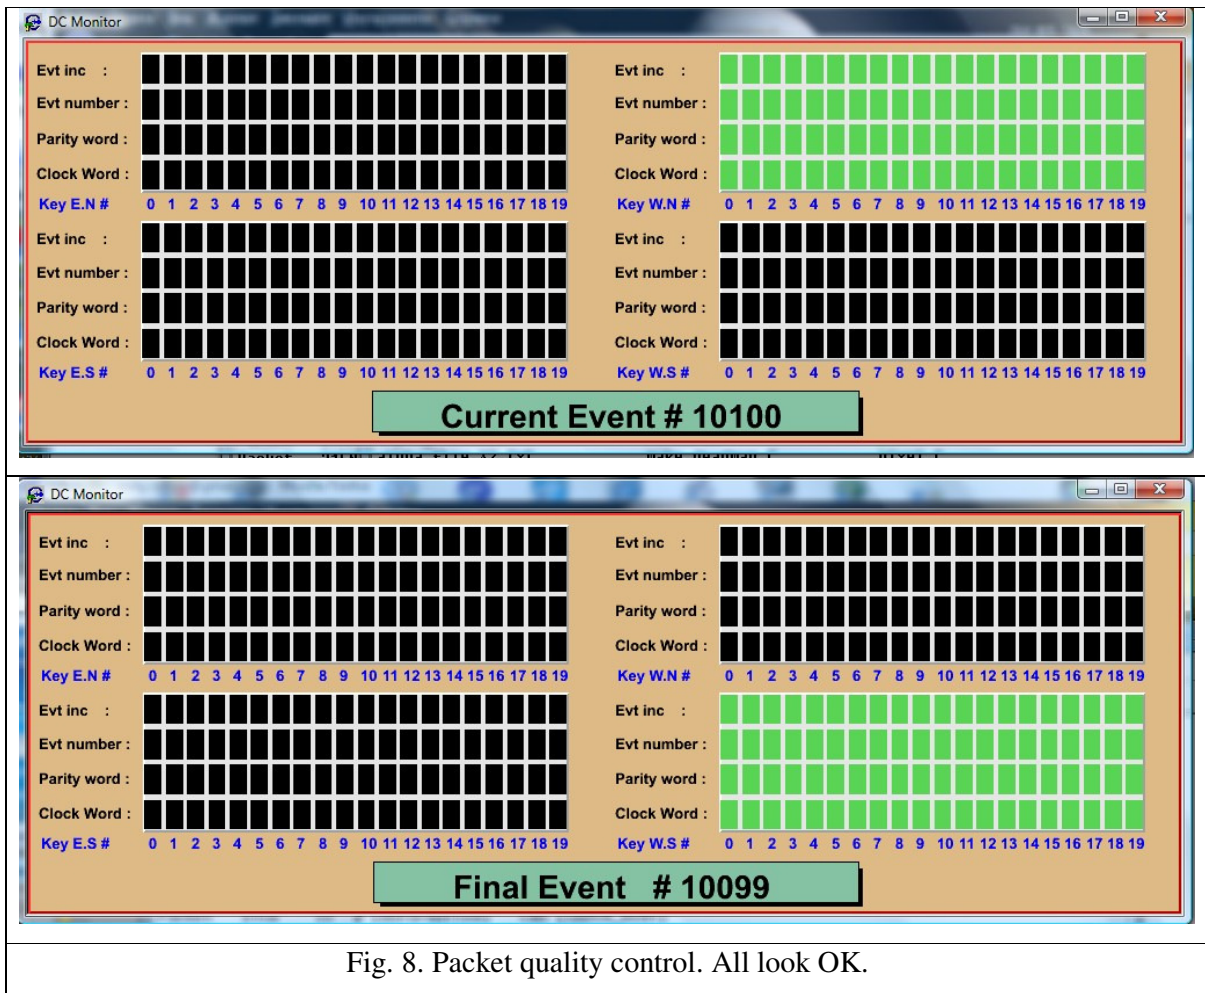
Fig. 8. Packet quality control. All look OK.

Internal format of the data packets is correct, see Fig. 8. Unfortunately, two problems with large packets (packet #3125 from North 12 and #3145 from North 2, which is equivalent to $4/80=5\%$ of the West acceptance) were not fixed (see Table 1) while tabletop tests did not find any problems. There was no time for the second iteration to work on these boards. This unclear problem has persisted over the past 5 to 6 years and will need additional work performed before Run 11. TMC boards can also be removed by working from the ladder, in addition to a man lift.
